# Product Change Notification

## TE Connectivity

Product Change Notification: P-26-030969

## ISL Lock position low resistance

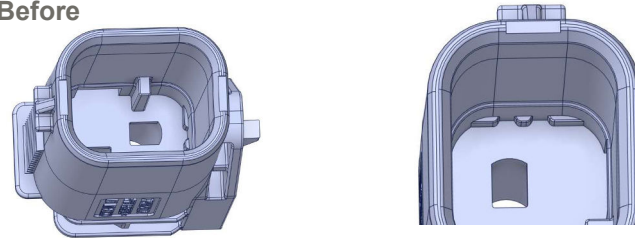
**Before**

- Male Housing p/n 2482012 and ISL p/n 2482016 fit and alignment has been improved to eliminate any ISL shifting during shipping, prior to terminal installation.
