Production Change Notice (PCN)

Supplier: Pulse Electronics (YAGEO Group)

PCN Title/No.: Manufacturing location addition - PCN-202603-001

Date: March 19, 2026

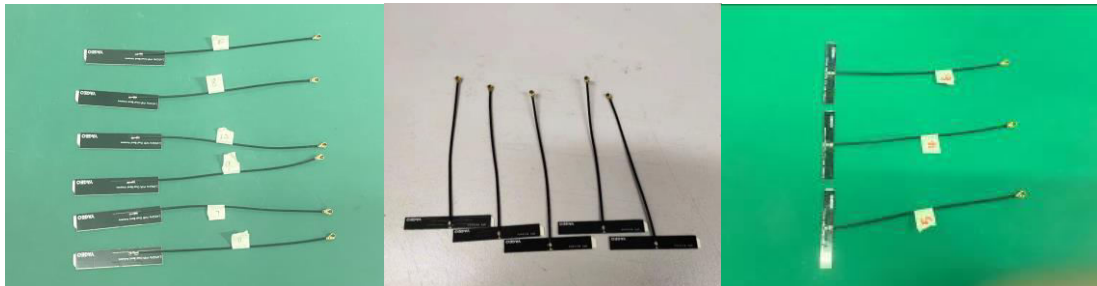
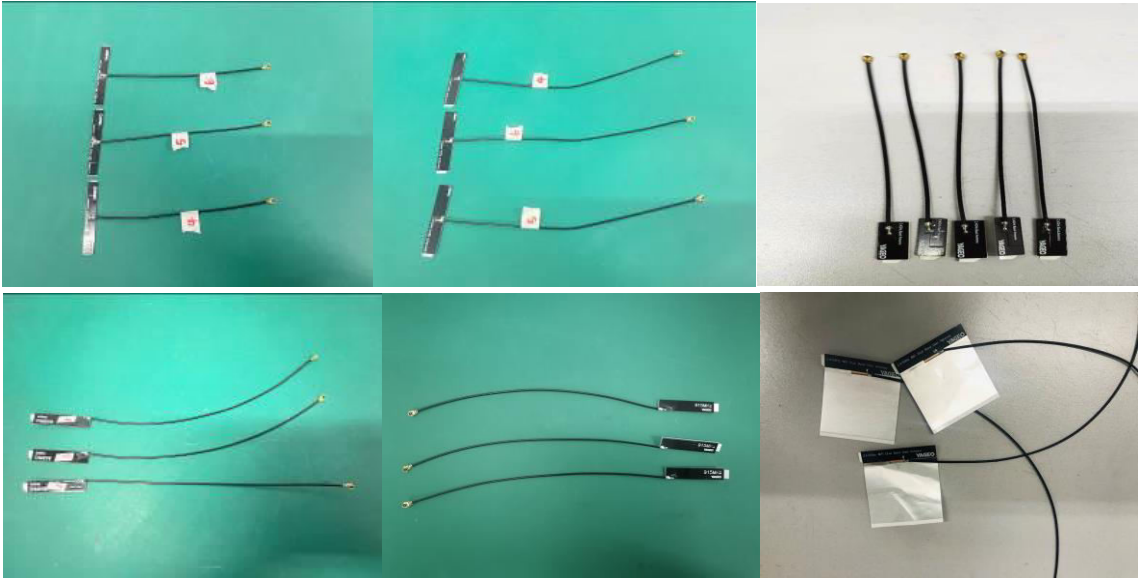
Fig.3: Appearance photos of the samples after test.

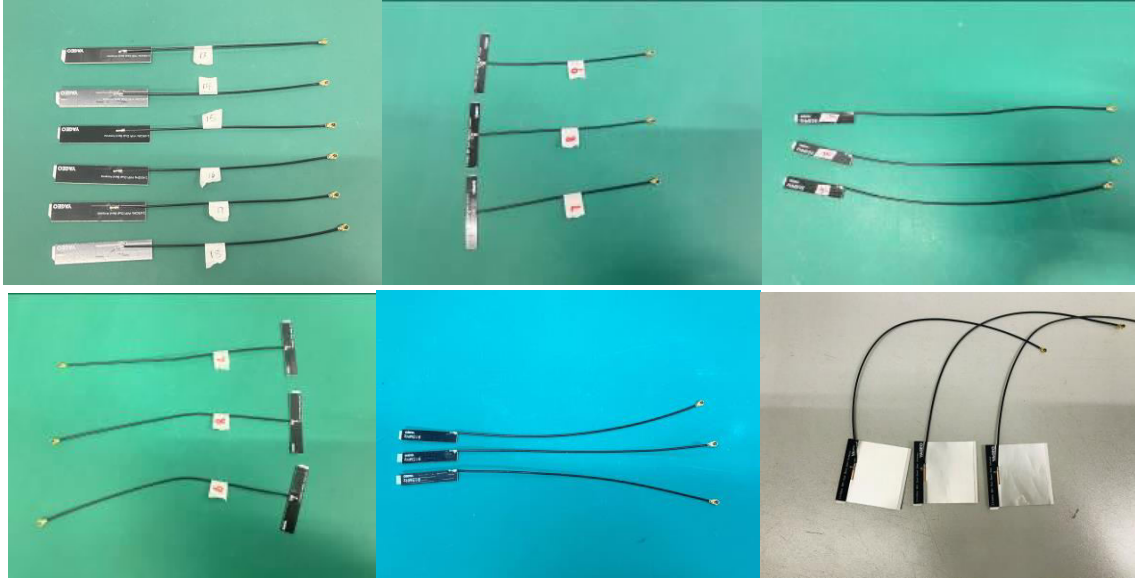
Test Result--- Damp Heat Cyclic test 湿热循环测试

Fig.1: Appearance photos of the samples before test.

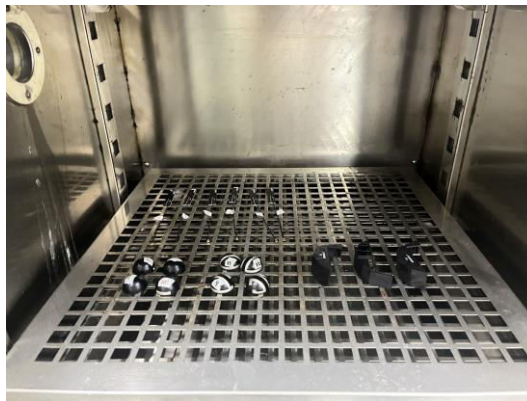
Fig.2: Photo of samples in test process.(实验条件/曲线)

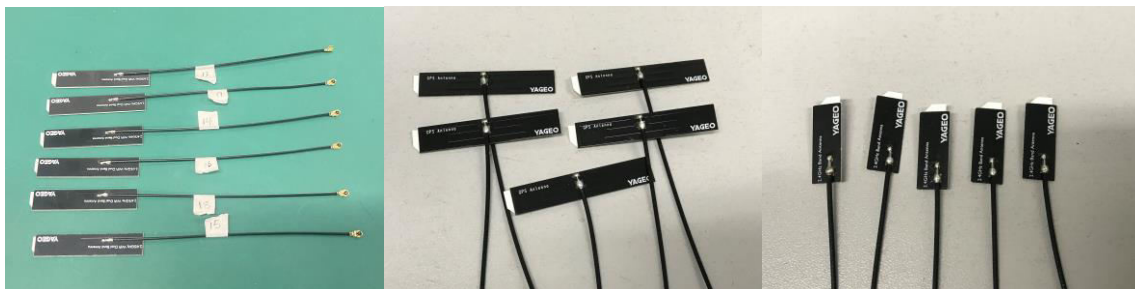
Fig.3: Appearance photos of the samples after test.

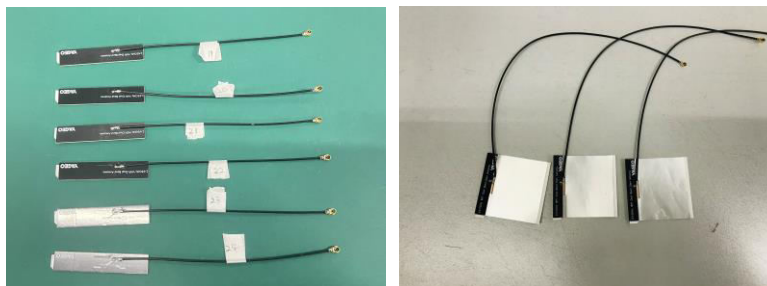
Test Result--- Temperature Cycling test 温度周期变化

Fig.1: Appearance photos of the samples before test.

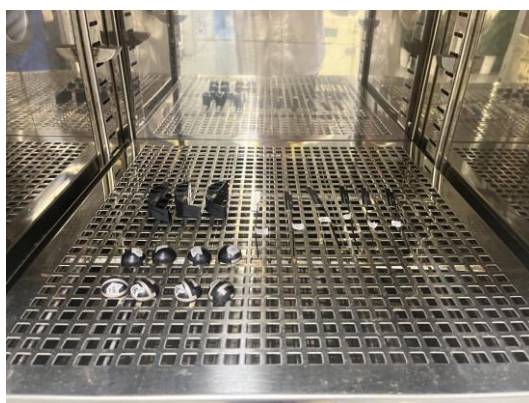
Fig.2: Photo of samples in test process.(实验条件/曲线)

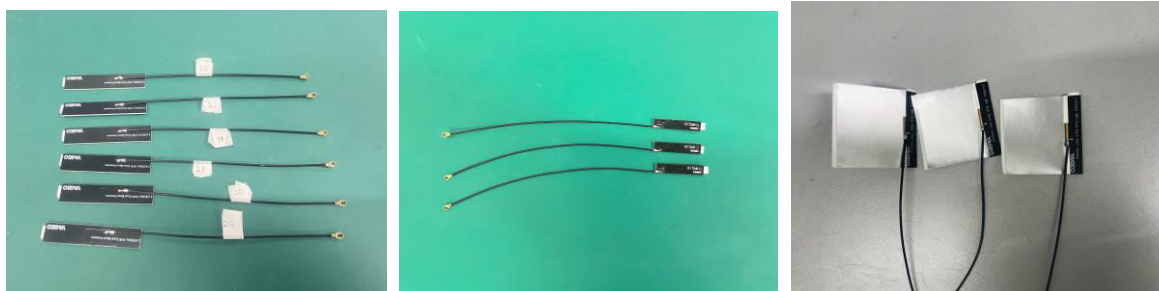
Fig.3: Appearance photos of the samples after test.

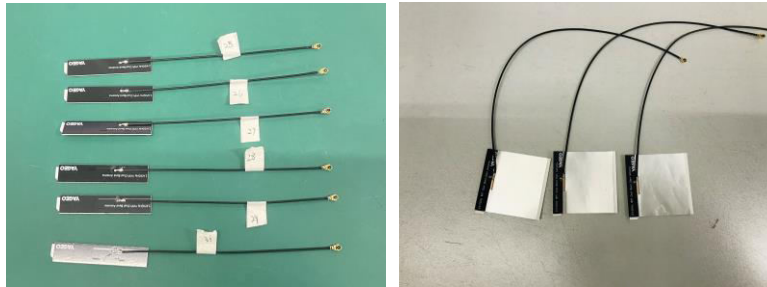
Test Result--- Thermal shock test 冷热冲击试验

Fig.1: Appearance photos of the samples before test.

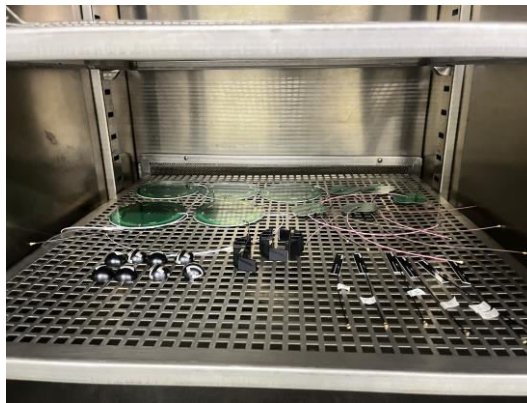
Fig.2: Photo of samples in test process.(实验条件/曲线)

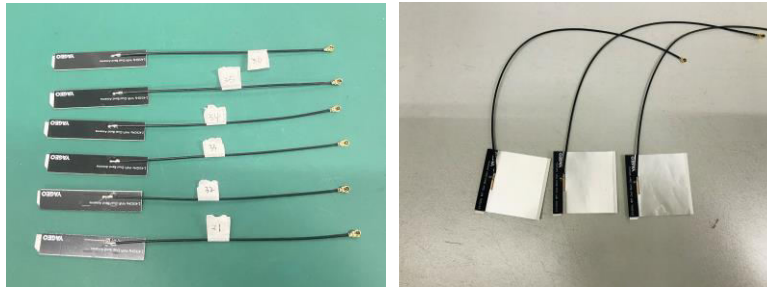
Test Result--- Salt mist test 盐雾测试

Fig.1: Appearance photos of the samples before test.

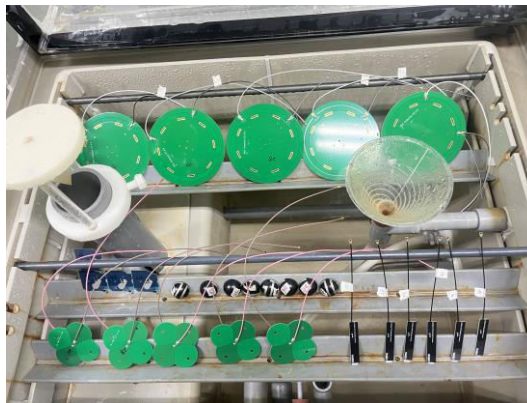
Fig.2: Photo of samples in test process.(实验条件/曲线)

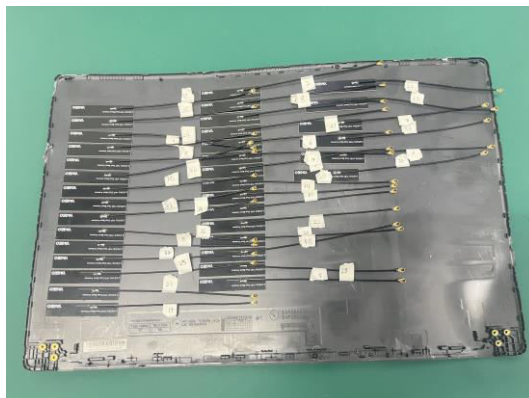
Test Result--- Drop test 跌落试验

Fig.1: Appearance photos of the samples before test.

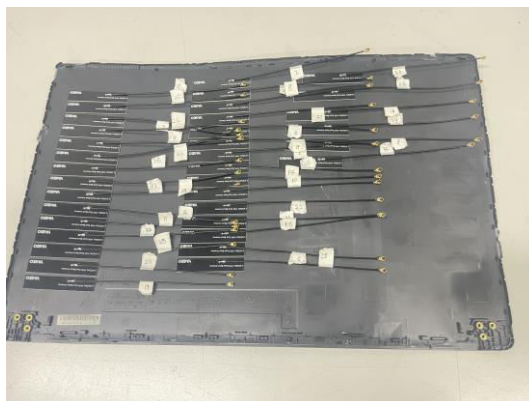
Fig.3: Appearance photos of the samples after test.
